Technical Bulletin

Subject: Exterior Rear-view Mirror, Wind Noise

Number: 99-04

Model(s): A4

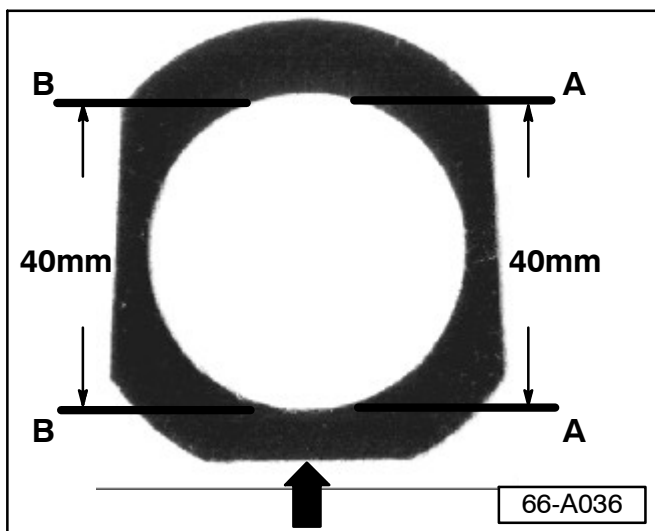
Wind noise heard near A-Pillar.

May be caused by a gap between the door mirror mount and housing.

- Remove tape.
- Cut a 40mm strip from adhesive backed felt washer Part No: 8D0 857 555 (allows felt washer to slip past mirror wiring harness).

◀ Illustration shows washer (felt side up, adhesive side down).

- ◆ Cut at -A- for left mirror.
- ◆ Cut at -B- for right mirror.
- ◆ Flat edge of felt washer -arrow- faces away from vehicle.
- Fold door mirror towards body.
